SUSPENSION & STEERING C12

## STABILIZER LINK / SWAY BAR LINK

- THE “RIGHT” TORQUE
- DETAILS MATTER
- PROVEN DURABILITY

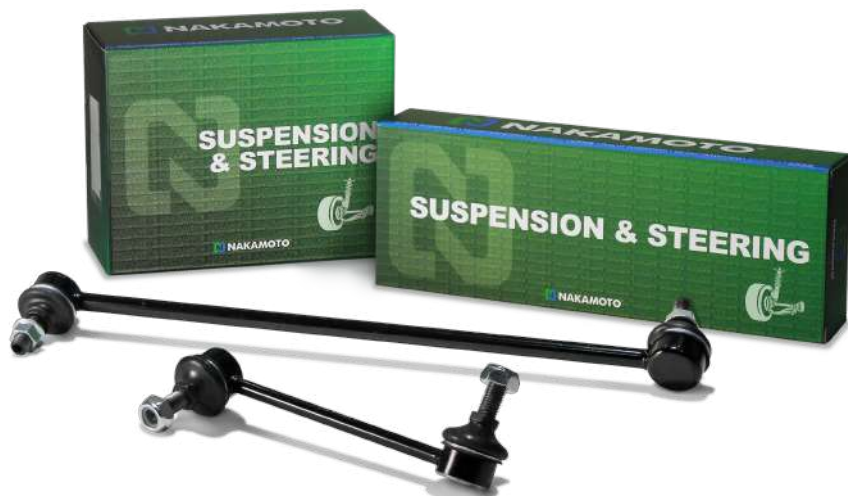
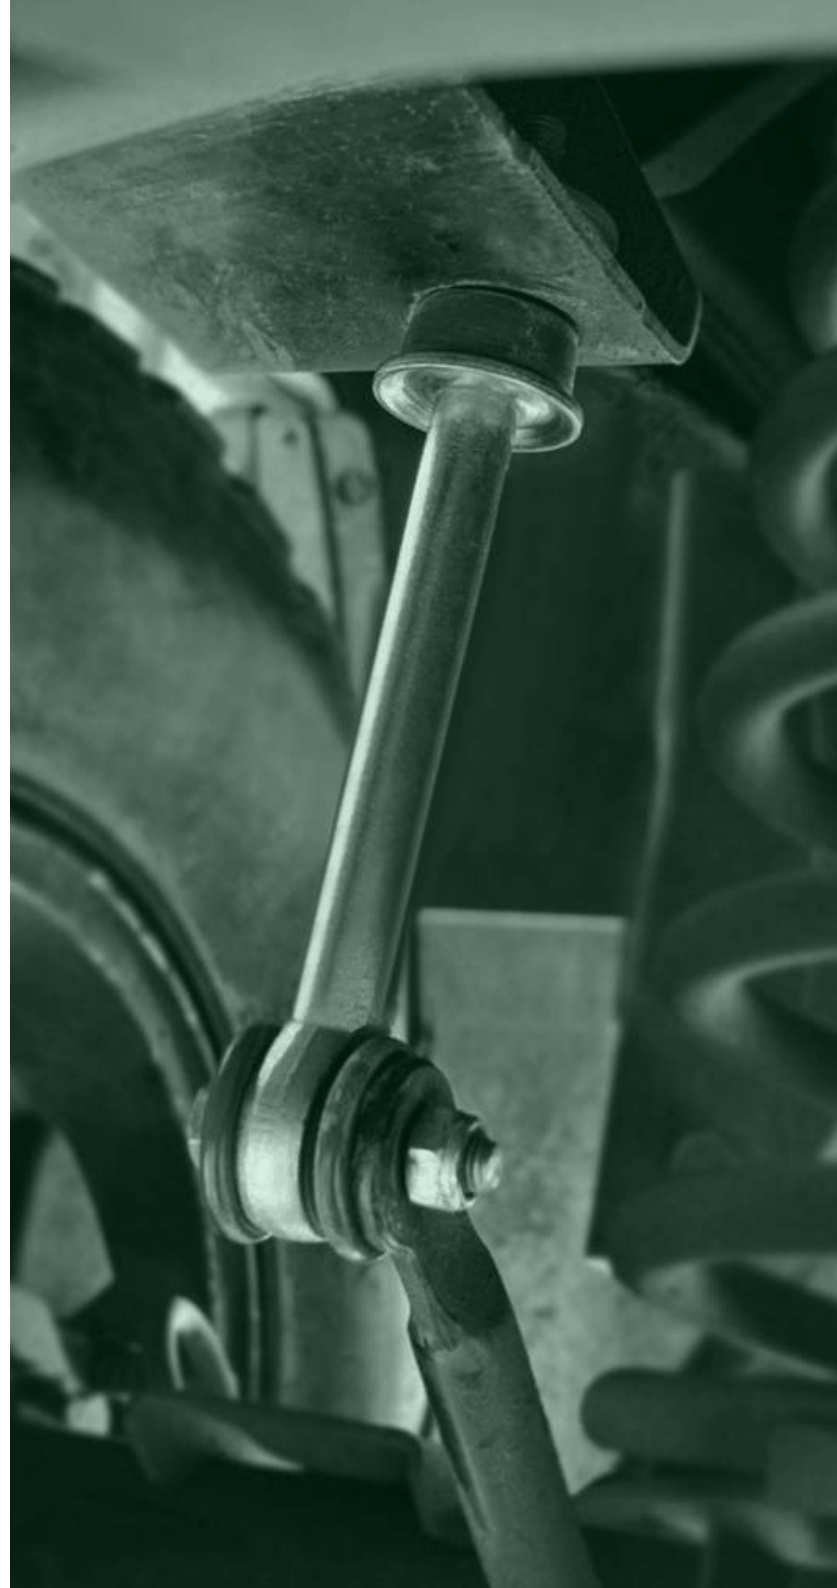
## Mirror-finished + “Right” Torque = Smooth Operation

Nakamoto utilizes 40Cr hardened ball studs with mirror-finished technology. Providing the “RIGHT” torque specification, perfectly coupled with the socket for smooth motion in all operating conditions.

Ball Stud	OEM	NAKAMOTO	Others
Torque ( $\leq 3.5$ Nm)	0.2 Nm	0.5 Nm	3.4 Nm
Roughness	Mirror-finished (Ra0.4 – Ra0.8)		Scratches & Dents (Ra0.8 – Ra1.6)
Machining	Precise CNC Forming		Welding Stud to Steel Ball
Pic

Excessive torque will increase unnecessary friction and lead to premature wear.  
Resulting in clunking and loose steering feel when encountering uneven road conditions.

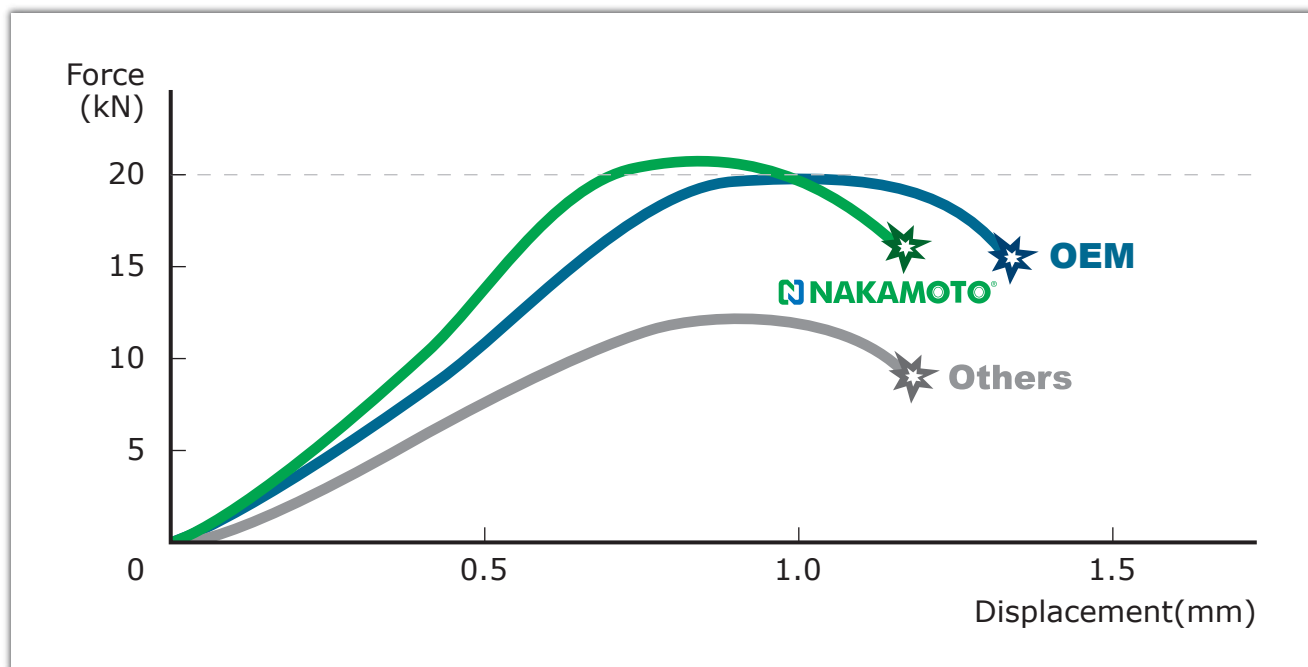
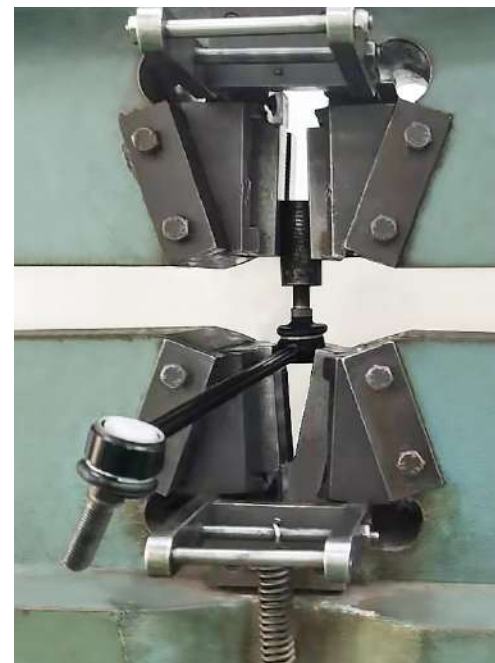
8-97235787-0 ISUZU D-MAX 2003-2011

Nakamoto stabilizer links offer true high load carrying capacity; withstanding up to 20kN in tensile strength, closely matching OE standards.

Rough machining can save up to 35% in cost, but it surely compromises load capacity and durability. Choosing quality stabilizer links = trouble-free down the road!
