Tested Independently: Quality You Can Trust

54501-25000 HYUNDAI ACCENT (1999-2006)

TEST REPORT

Mechanical & Hardgoods Laboratory

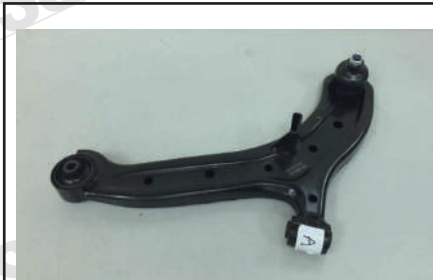
Photo A: Appearance of the sample A

Others

With less than 70% load, the competitor sample begins to fail. The base was deformed and testing was terminated.

Sample	Weigh (kg)	Max. force (kgf)	Result
A (OTHERS)	3.09	3374.6	The universal joint wasn’t pulled out from the base, but the base was deformed.
B (NAKAMOTO)	2.89	5000.0	The universal joint wasn’t pulled out from the base.
C (OE)	2.96	5000.0	The universal joint wasn’t pulled out from the base.

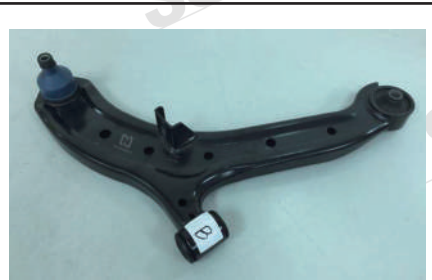
Photo B: Appearance of the sample B

NAKAMOTO®

Benchmarked against the OE product, the NAKAMOTO control arm sustained the maximum pressure of 5,000 Kgs without any sign of damage. A testament to the quality of our products and guaranteeing the safety of our customers.

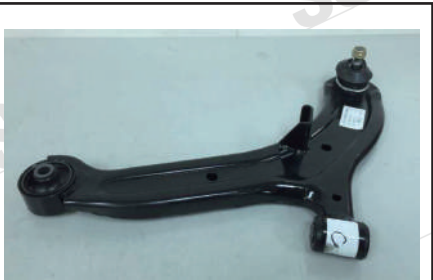
Photo C: Appearance of the sample C

OE

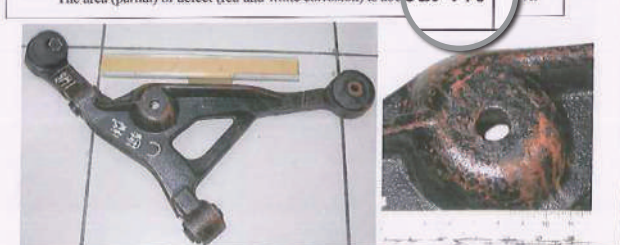
1. Testing method:  
(1). ASTM B117-11 Salt Spray (Fog) Testing  
(2). ASTM D610-08 (Reapproved 2012) Standard Practice for Evaluating Degree of Rusting on Painted Steel Surfaces  
2. Testing equipment: ERICHSEN Salt Spray Tester  
3. Testing environment: Room temperature 18~23℃  
4. Testing condition: Chamber temp. 35℃, 5%NaCl, PH6.9, 1.6 ml/hr/80cm<sup>2</sup>, Specific gravity 1.0320  
5. Sample name: Control Arm C  
6. Testing period: 24 hours  
7. Testing result: Please refer to the below and the following photo.

Test results in eyeshot (corrosion sources)

The area (partial) of defect (red and white corrosion) is about 4%

Others

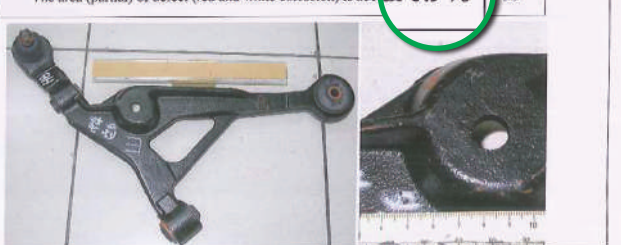
1. Testing method:  
(1). ASTM B117-11 Salt Spray (Fog) Testing  
(2). ASTM D610-08 (Reapproved 2012) Standard Practice for Evaluating Degree of Rusting on Painted Steel Surfaces  
2. Testing equipment: ERICHSEN Salt Spray Tester  
3. Testing environment: Room temperature 18~23℃  
4. Testing condition: Chamber temp. 35℃, 5%NaCl, PH6.9, 1.6 ml/hr/80cm<sup>2</sup>, Specific gravity 1.0320  
5. Sample name: Control Arm E  
6. Testing period: 24 hours  
7. Testing result: Please refer to the below and the following photo.

Test results in eyeshot (corrosion sources)

The area (partial) of defect (red and white corrosion) is about 0.9%

NAKAMOTO®

NAKAMOTO control arms uses the latest coating technology to maximize the service life of our products. Tested and proven to outperform our competitors.
